Manhole Inspection Summary

Manhole # S17G__028MH

Insp Date: **1/26/09 9:20 AM**

Location Address: **2342 VINE-FAYETT**

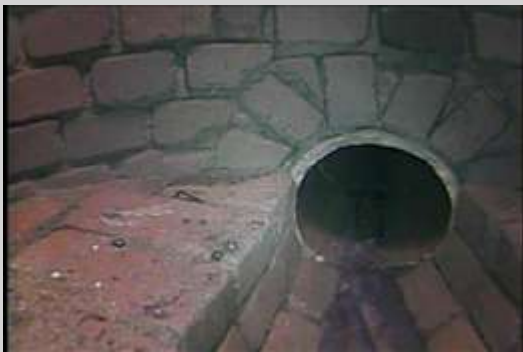
12 O'Clock Outflow

8 in. Circular Gravity Sewer
Pipe Out @ 12 O'Clock

Pipe Height: **7.2** (in.) Rod and Bar (Angled)
Pipe Material: **Clay** ☐ Pipe Lined
Invert Depth: **6.68** (ft.) Flow Characteristics: **Slow**
Deposits: ☒ None ☐ Mud ☐ Sludge ☐ Debris ☐ Grease
Silt Depth: (in.) Deposits Extent:
Infiltration: **None** Pipe Seal Cond: **Sound**

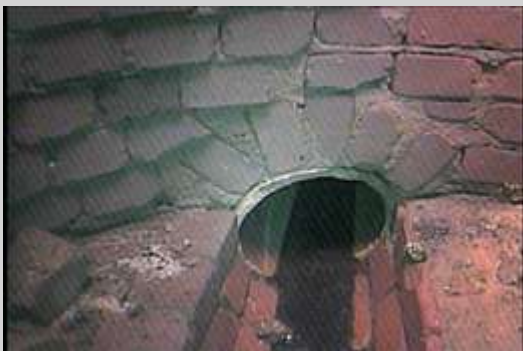
5 O'Clock Inflow

8 in. Circular Gravity Sewer
Pipe In @ 5 O'Clock

Pipe Height: **7.2** (in.) Rod and Bar (Angled)
Pipe Material: **Clay** ☐ Pipe Lined
Invert Depth: **6.73** (ft.) Flow Characteristics: **Slow**
Deposits: ☒ None ☐ Mud ☐ Sludge ☐ Debris ☐ Grease
Silt Depth: (in.) Deposits Extent:
Infiltration: **None** Pipe Seal Cond: **Sound**
